Subchondral bone failure in overload arthrosis: A scanning electron microscopic study in horses

R.W. Norrdin¹ and S.M. Stover²

¹Department of Microbiology Immunology and Pathology, College of Veterinary Medicine and Biomedical Sciences, Colorado State University, Fort Collins CO, USA; ²J.D. Wheat Veterinary Orthopedic Research Laboratory, School of Veterinary Medicine, University of California at Davis, Davis CA, USA

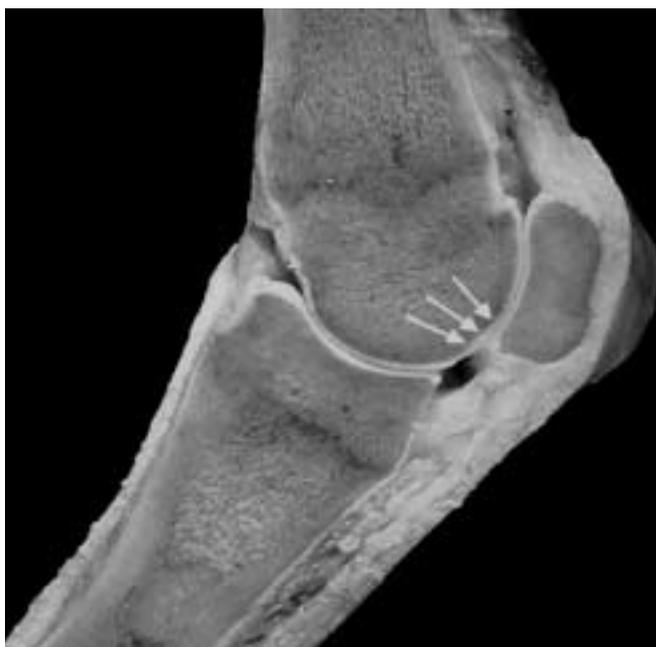
Figure 1. Equine fetlock joint. The area on the palmar surface of the condyle where overload arthrosis and subchondral bone failure occurs is indicated with arrows.

Subchondral sclerosis and areas of bone devitalization are common in the overload arthrosis of equine athletes^{13,14}. Actual subchondral bone failure occurs focally in the palmar metacarpal condyle of the fetlock joint (Figure 1) where indentation and collapse of the articular cartilage is seen. This is referred to as 'traumatic osteochondrosis'^{14,15}. It is primarily a disease of racehorses and is very common in the US. It is often asymptomatic but more severe forms are asso-

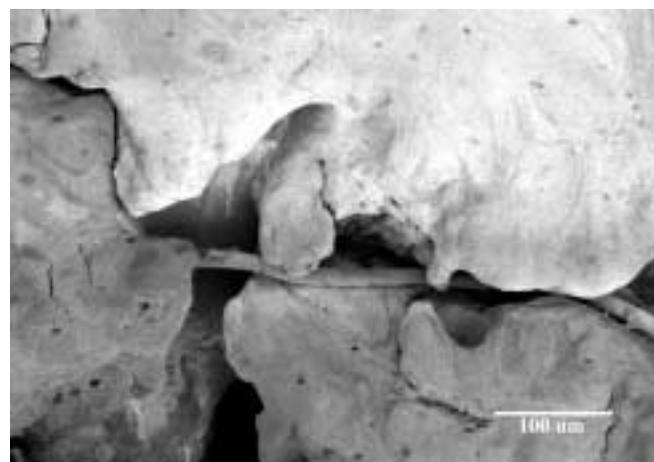
Figure 7. Higher magnification of microfracture gap with entrapped vessel from Figure 6. Note smooth edges on ground fragments indicating chronic wear on the surfaces.
